Geomorphic Responses to Stream Channel Restoration at Minebank Run, Baltimore County, Maryland

Project Leads: Edward J. Doheny and Jonathan J.A. Dillow

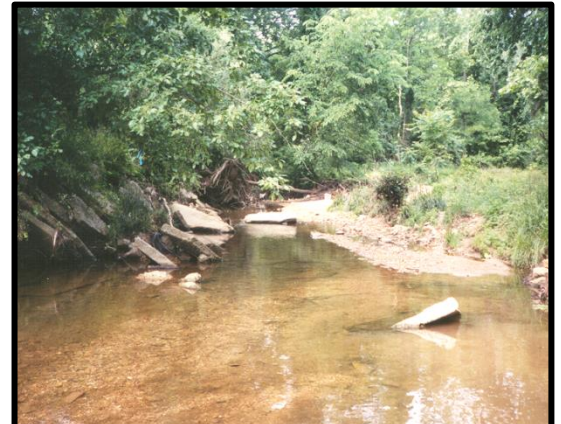
Looking upstream at centerline of stream channel from station 0158397967, Minebank Run near Glen Arm, MD, June 2004, just prior to physical restoration in the gage reach.

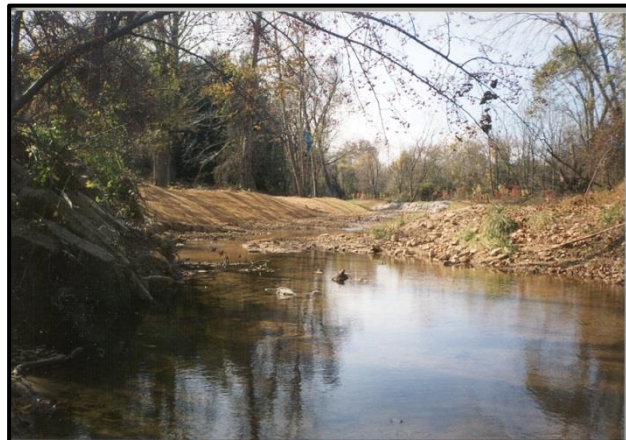
Looking upstream at centerline of stream channel from station 0158397967, Minebank Run near Glen Arm, MD, October 2004, just after physical restoration in the gage reach.
